CANADIAN FORCES FLIGHT SAFETY INVESTIGATION (FSI) REPORT (FSIR)

FINAL REPORT

FILE NUMBER: 1010-12401 (DFS 2-4-2)
DATE OF REPORT: 27 Sep 04

AIRCRAFT TYPE: CH124A Sea King
DATE/TIME: 27 1403Z/1103 R (Local) Feb 03
LOCATION: HMCS IROQUOIS, 41 36N 051 39W (540 NM ESE Halifax)
CATEGORY: "A" Category Accident

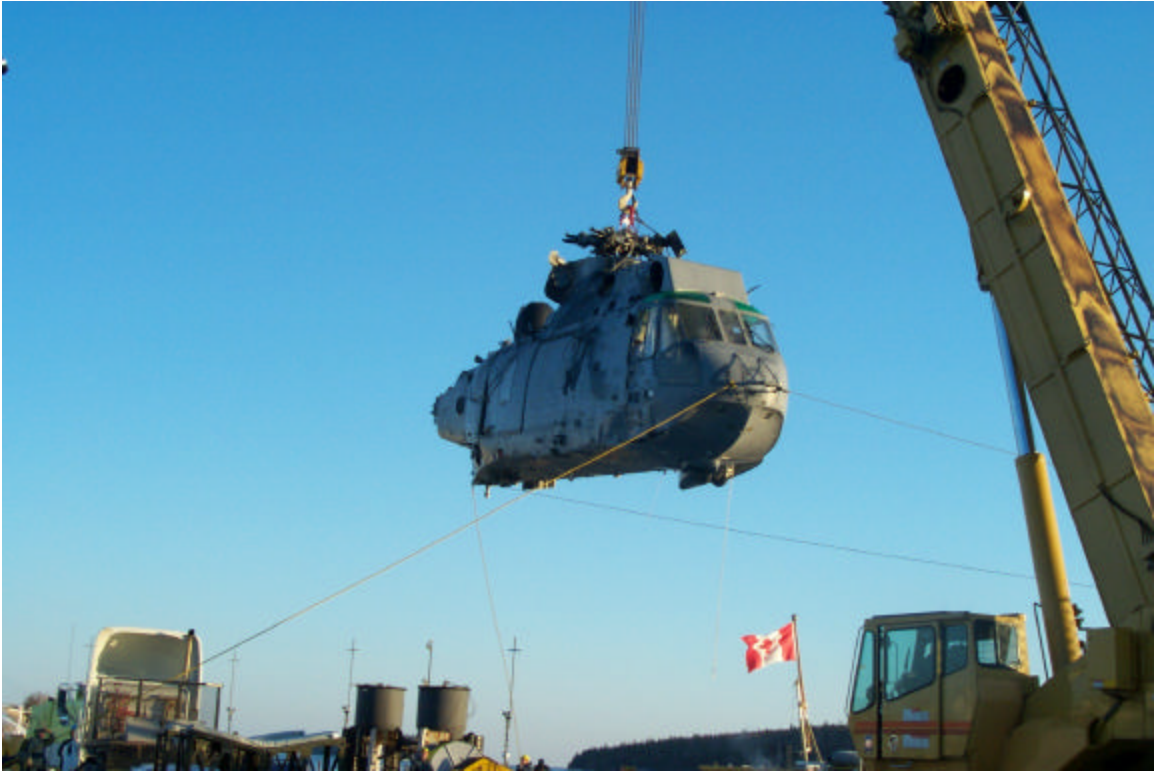
Photo 3: Salvage Operations

IROQUOIS came alongside the Shearwater Jetty at 12 Wing, NS, for crane-off operations that were directed by the 12 AMS Salvage Team (Photo 3). Recovery to the jetty flatbed trailer was done in five phases: the attachment of crane harness assembly to the main rotor head hub; the aircraft raising to the vertical position over the flight deck; a final structural assessment of the aircraft and further photographic documentation; the craning off of the aircraft to the jetty flatbed trailer; and the securing of the aircraft to pre-positioned cradles on the flatbed trailer. The aircraft was then moved to and secured in a hangar facility for further investigation.
